Project: 5468 Honnert, OH Oil Spill Clean-up

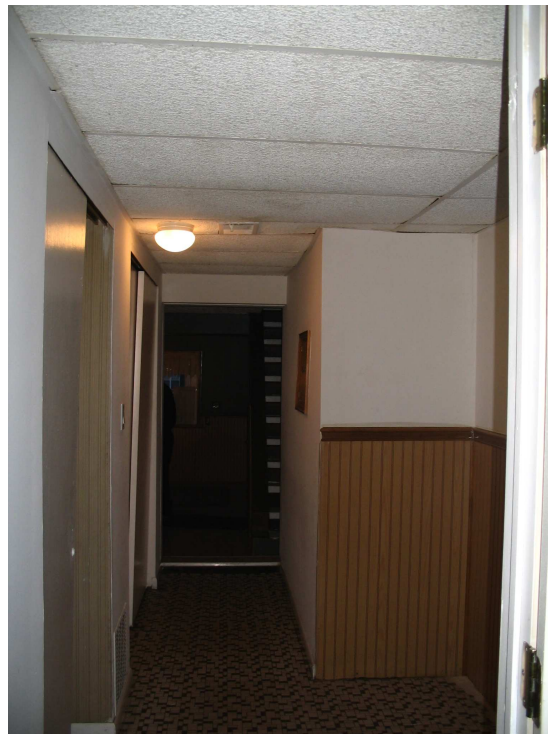
HALLWAY WITH OIL TANK AND ENCLOSURE (NOVEMBER 2005)

This picture is taken before we purchased the property. The house is built on a slab foundation. There was a fuel oil furnace located on the left side of this hallway. The oil tank was behind this enclosure on the right side of the hallway. It appears to have originally been *outside* the house, and then it was enclosed when an addition to the original house was made. Note the small 1 foot square opening on the enclosure. This is the window the owner would look through to observe the fuel level of the tank. The oil spill occurred when he did not notify the person filling from the truck that the tank was full. See the EPA report for details on this spill and the so-called clean-up.

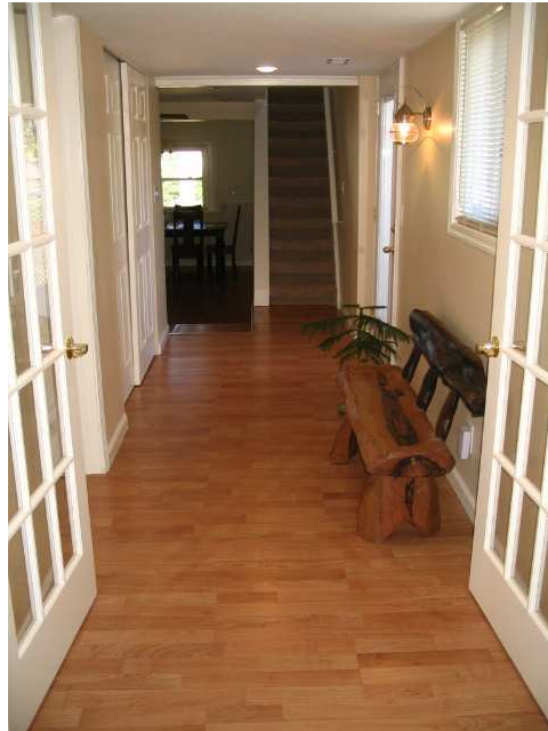
AFTER INITIAL RENOVATION OF HALLWAY (MARCH 2006)

This is a photograph from the same end of the hallway after renovations were made before we moved to the house in March 2006. The oil tank was removed. The vapor affected drop ceiling and drywall/insulation in the entire hallway was replaced. A door was installed to the exterior of the house where the oil tank used to be and oil affected wood was removed. The floor of the hallway was skim coated with concrete and a 6 mil plastic vapor barrier was put down under the wood laminate. Note: there was no smell of oil whatsoever for the first month or so. Then the oil vapor began to emerge from the corner of the hallway, underneath the door to the exterior, especially on rainy days. This is the lowest point in the floor, where the oil would have flowed and where the concrete slab of the hallway meets an interior cinder block wall (originally an exterior wall of the house but subsequently enclosed). The house was closed without ventilation for a week at the end of June and when we returned the oil smell was noxious throughout the house.

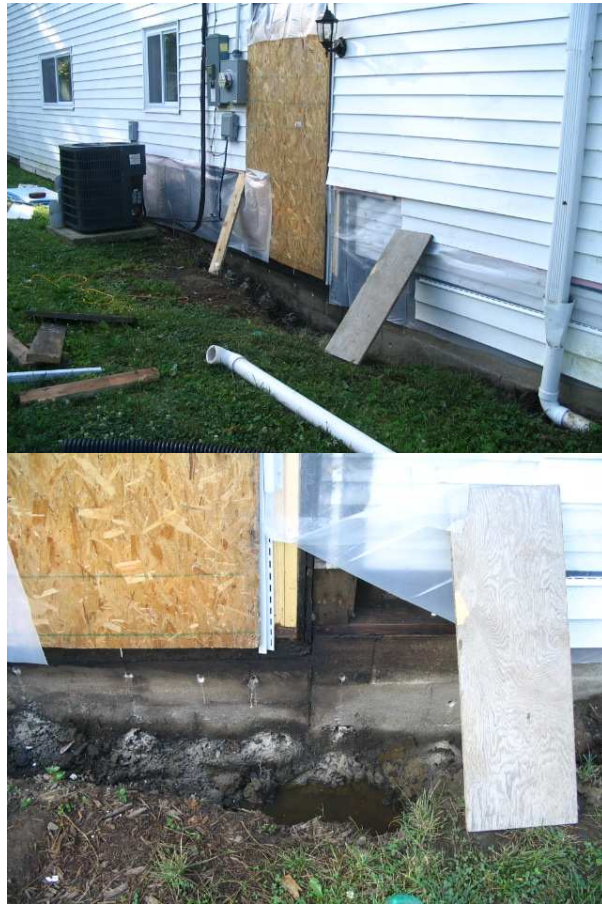
OUTSIDE DURING DIGGING

Siding was removed at the bottom of the house in the oil spill location and oil saturated wood was removed. Oily dirt was removed. VaporRemed was sprayed in this area and onto the concrete floor inside, but the odor remained. Holes were drilled into the cinder block outside the house and into the concrete slab inside the house. Gallons of VaporRemed were sprayed in both, but the oil smell returned through the floor and from the cinder blocks. This led to taking up the concrete slab of the hallway.

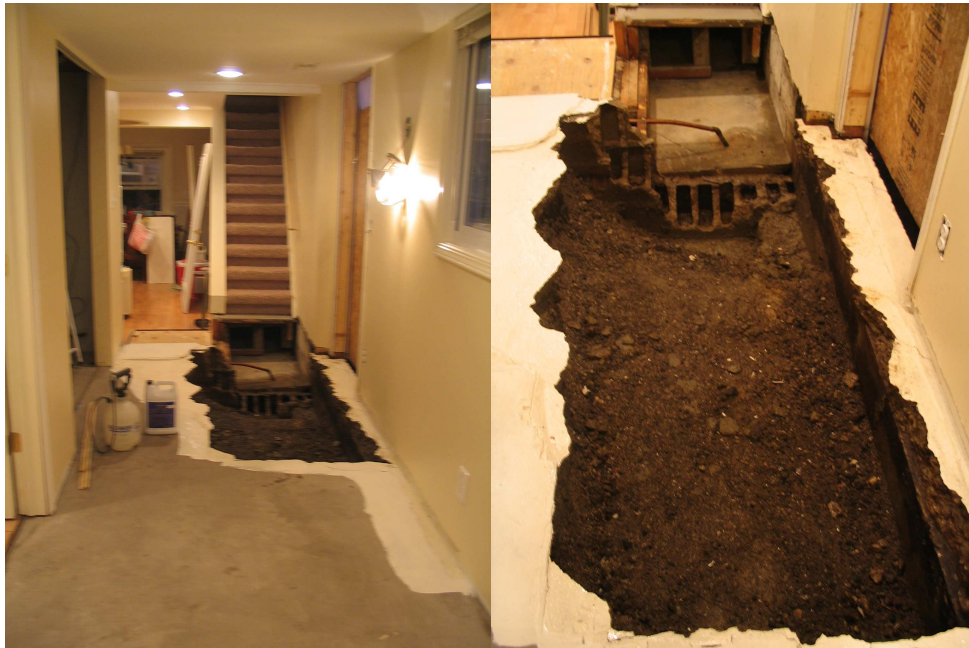
HALLWAY DURING DIGGING

These photos show an early stage of demolition and oil removal. The landing at the bottom of the stairs was removed and concrete/cinders/dirt was taken out by hand. VaporRemed was used during the process to keep the oil vapor from contaminating other areas of the house. Note the hollows of the cinder block at the end of the hallway. This was a low spot that the oil seeped towards. At this point the hope was that dirt could be removed and VaporRemed sprayed into the exterior cinder block foundation wall from both sides to deal with the problem. This proved unsuccessful, and about 12-14 feet of the exterior cinder block foundation wall and 10-12 feet of the interior cinder block foundation wall had to be removed.

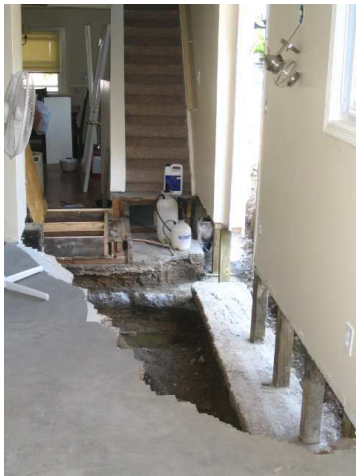
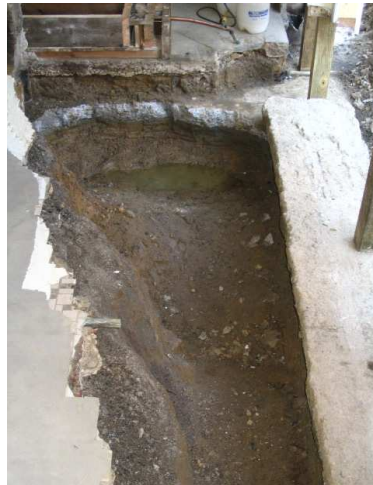
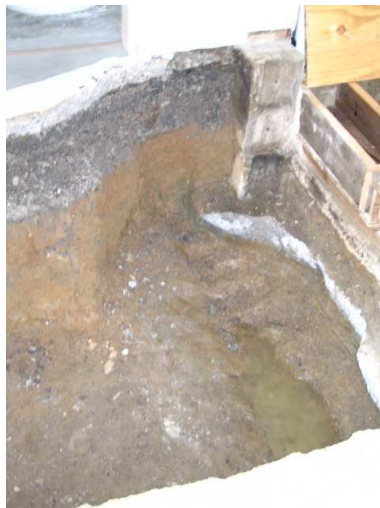
CONTAMINATED SOIL AND CINDER BLOCK REMOVED

The oil-saturated dirt was a greenish-gray color, in contrast to the brown that is visible in these photos. It emitted an extremely strong, sweet odor. Here you can see the cinder block foundation wall removed and contaminated soil removed below the level of the footer. The bottom photo shows the hole of about four feet in depth and the interior cinder block wall that still needed removed. This required removing the kitchen floor and one wall of the kitchen. VaporRemed was utilized again when all the contaminated areas were extracted. There was an oil odor, though significantly diminished, even after removal of the dirt and cinder block. Thanks to VaporRemed, though, even this slight odor disappeared and did not return.

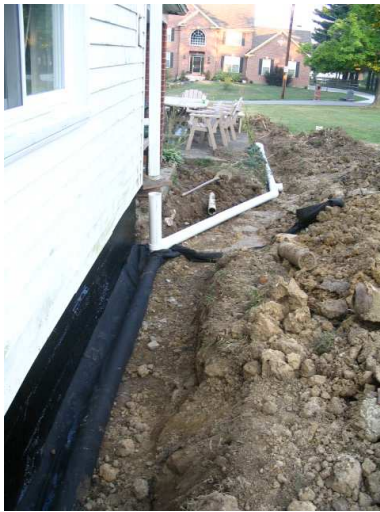
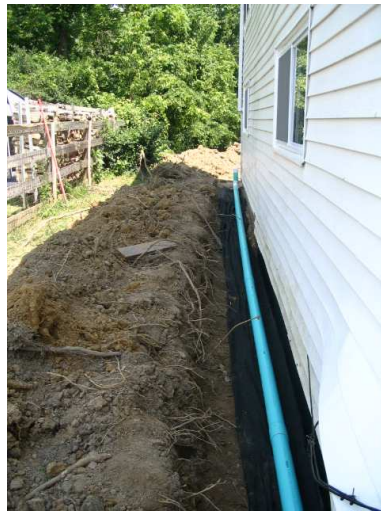
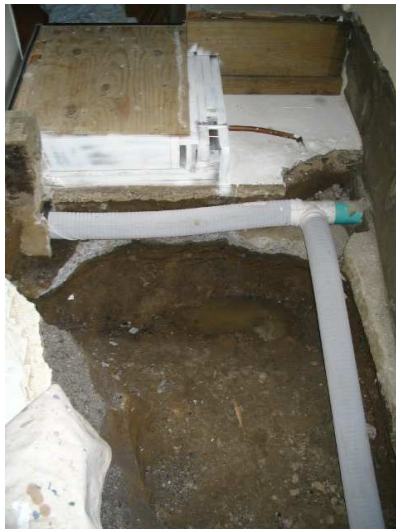
NEW FOOTER-DRAIN IRRIGATION SYSTEM INSTALLED

When the EPA treated the problem in March of 2005, then simply dug up some soil at the side of the house and blocked the old clay drain tile to prevent any oil seeping into the storm drain system which led to a creek ½ mile away. This creek is where the oil was first detected by neighbors. This created a new problem—water sitting alongside the house, right where the oil spill occurred, with nowhere to go but under the slab foundation and into the cinder block foundation wall. These photos show the new irrigation. Note in the bottom photo the perforated black pipe that connects the outside system to the inside of the house, in the hole where the oil affected dirt was removed. IF there was any future residual odor that surfaced under the hallway, it would rise through the fill gravel to the plastic vapor barriers and follow the perforated pipe outside.
